# Laguna de Bay 2013 Ecosystem Health Report Card

Ibalik ang diwa ng lawa Restore the ecological balance of the lake

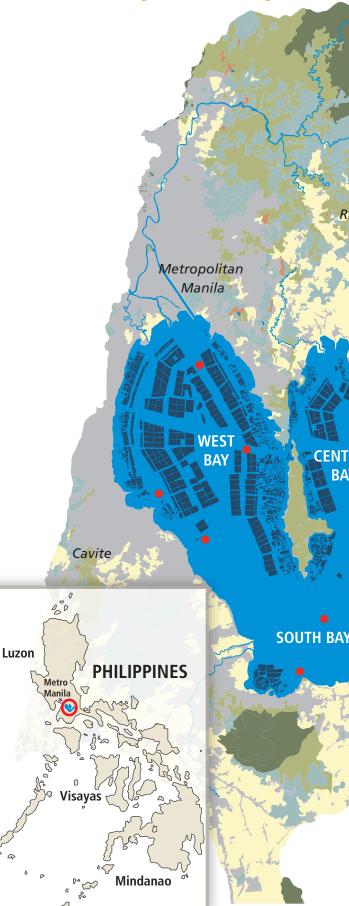
Laguna de Bay scored a low passing mark, 76%, a C-, in water quality. The Lake consistently is within the Department of Environment and Natural Resources (DENR) guidelines for class C waters in DO, BOD, nitrate, and total coliforms. However, it scored 0% in chlorophyll *a* and 59% in phosphates. Water quality was affected by high population and industralization.

The Lake received an F in Fisheries (48%), with 53%, 68%, and 22% scores in fish native species composition, zooplankton ratio, and catch per unit effort (CPUE), respectively. Invasive fish species and competition among fisherfolk contributed to the low scores.

Even though the DENR guidelines are met in most water quality indicators, the chlorophyll *a*, phosphates, and zooplankton ratio scores show that the Lake is highly eutrophic. These results have a negative impact on the fisheries of Laguna de Bay. Overall, these scores are not only a cause of concern for fisheries, but the whole community and all the industries supported by the Lake.

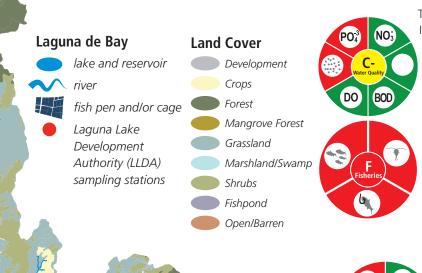
The West Bay has the second lowest water quality score, 76%. It is the most heavily developed side of Laguna de Bay and most populated. For 2013, its DO, BOD and nitrate were within DENR's guideline for class C waters (100%) and its total coliforms at 98%. However it has the second lowest score in phosphates (56%) and like all the bays, received a 0% in chlorophyll *a*. This scores reflect its high population density and the need to reduce phosphorus runoff into the Lake.

The Central Bay has the lowest water quality score at 71%, however, its 65% score in Fisheries is the highest of all bays. Although it scored 100% in nitrate, DO, BOD, and total coliforms, it had the lowest score in phosphates with 25%, and a 0% in chlorophyll a.

The East Bay has the highest water quality score at 81%. It received an A in all water quaity indicators except for chlorophyll *a* (0%, an F). However, the East Bay scored the lowest in fisheries with 28%, scoring a mere 3% for CPUE.

The South Bay has the second highest score in water quality at 77%, with 100% in nitrates, DO, BOD, and total coliforms. Like all the bays, it has a 0% in chlorophyll *a* and an F in phosphates at 63%. It had the second lowest score in fisheries, 43%, with the lowest score in native fish species composition at 37% even though a designated fish sanctuary is located within the South Bay.
